Misguidance under the Polish Tu-154 Crash

Abstract - The crash of Tu-154 has taken place in 10th April 2010 in Smolensk, USRR. The weather of that day was highly foggy, so the crew has been thrown back on the ground navigation facilities. These, in turn, have the obsolete instruments and present the extremely low standard of maintenance. In result, Tu-154 was directed to the woody area 1000x150 m aside the airport. Then, it collided with a tree and lost the large part of the left wing. This caused the plane to turn around its longitudinal axis. The process of turning is analyzed in detail via Newtonian differential model. The time of revolution on the back has taken merely 8 seconds. The plane hit next on the ground and produced thousands of small and large parts. The mean dispersion reached 300 meters. This process is modeled via parabolic equations under the assumption of 100% resiliency of the ground. Nobody of passengers survived. The final conclusion is as follows: the Tu-154 should not obtain the permission for 3 trials of lending in the extremely bad weather and much confusing maintenance from the ground station.

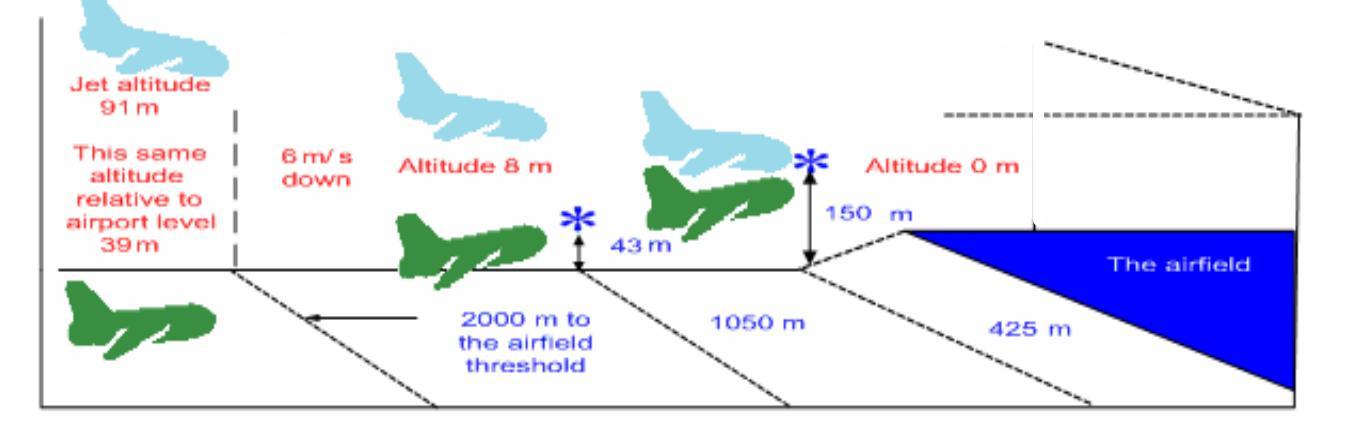
Fig.2. The provisional front views (blue profiles) and the top views (green profiles) of the Tu-154M final flight.

The blue data denote distances to the front- and left side of the runway

It, however, could be moderate if the curse of flight was towards the runway. Unfortunately, it was -10^{0} left the runway, Fig.2. So, the collisions with trees were unavoidable. The first one took place with a birch of thickness of ~40 cm and it caused the plane to overturn.

Next, there were still smaller collisions and the final ground crash took place 625 m further, see blue star 150.

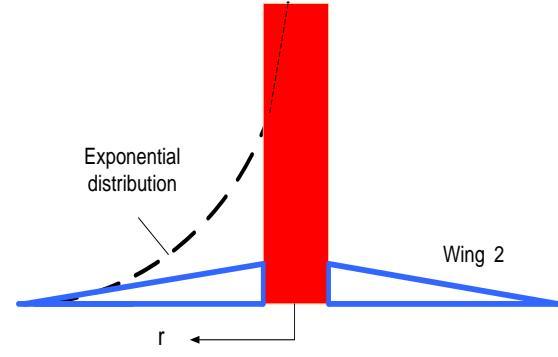
Fig. 3a. The approximation of mass distributions

the plane *Mdr* across the wings' line by the triangular and rectangular functions, Fig.3. Next, we will express them by an exponential function $m(r)\approx e^{-r}$. Hence, the important parameter, the arm of inertia is

$$k = \int_{0}^{19} e^{-r} r^{2} dr = e^{-r} (-r^{2} - 2r - 2) \Big|_{0}^{19} \approx 2 m \quad (5)$$

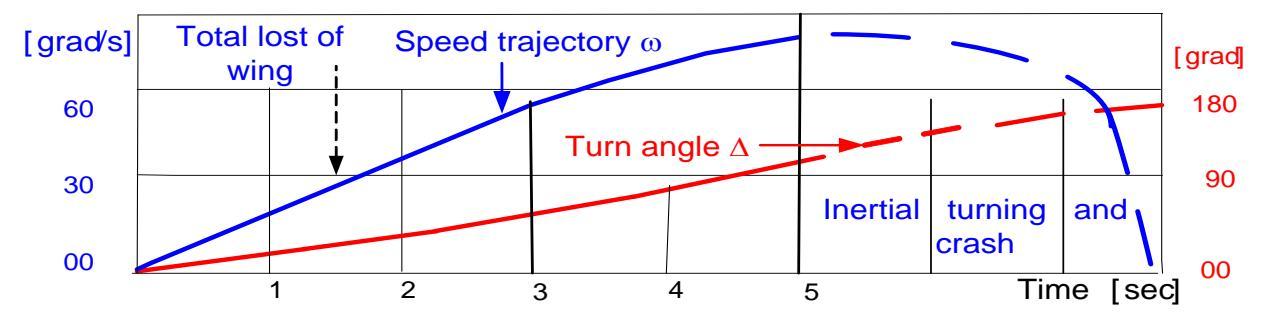
Fig.4. The speed and angle of the rotation process vs time: the plane reaches the angle $\Delta \approx 90^{\circ}$ nearly in 5 s

The force *F* appears as the effect of lost part of the wing and it is taken 10% of the total gravitation force, i.e. F=0.1*M. Hence, for r=13 m and $k^2=4$ m² we obtain the equation for the speed ω

(6)
$$\omega(t) = (F/M)^* (r/k^2)t = (0.1)^* (13/4)t = 0.33 t [rad./s]$$

It means that in 1 second the plane turns around by 0.33 of radian, i.e. $\sim 20^{\circ}$. All the process of rotation is illustrated in

Fig. 4 (blue curve) together with the hypothetical fall down curve (red curve). It is worth to note that the forward speed was ~280 km/h (~80 m/s), which responds to the falling down of a body from 30 m (10-floor building)! So, no one passenger could survive!
